Date: 18th March 2015
Author: Dr Nickie Smith
Report Number: C3810-2

HiTACC – Characterisation of Anti-corrosion Coatings

A study has been conducted to assess a range of high temperature anti-corrosion coatings (HiTACC) which are being developed for high temperature service environments. As part of the project three candidate coatings, were exposed to a realistic service environment which represents a worst case scenario, that is, a hot/wet environment at pressure. This report provides the results for one of the coatings as detailed in Table 2.1

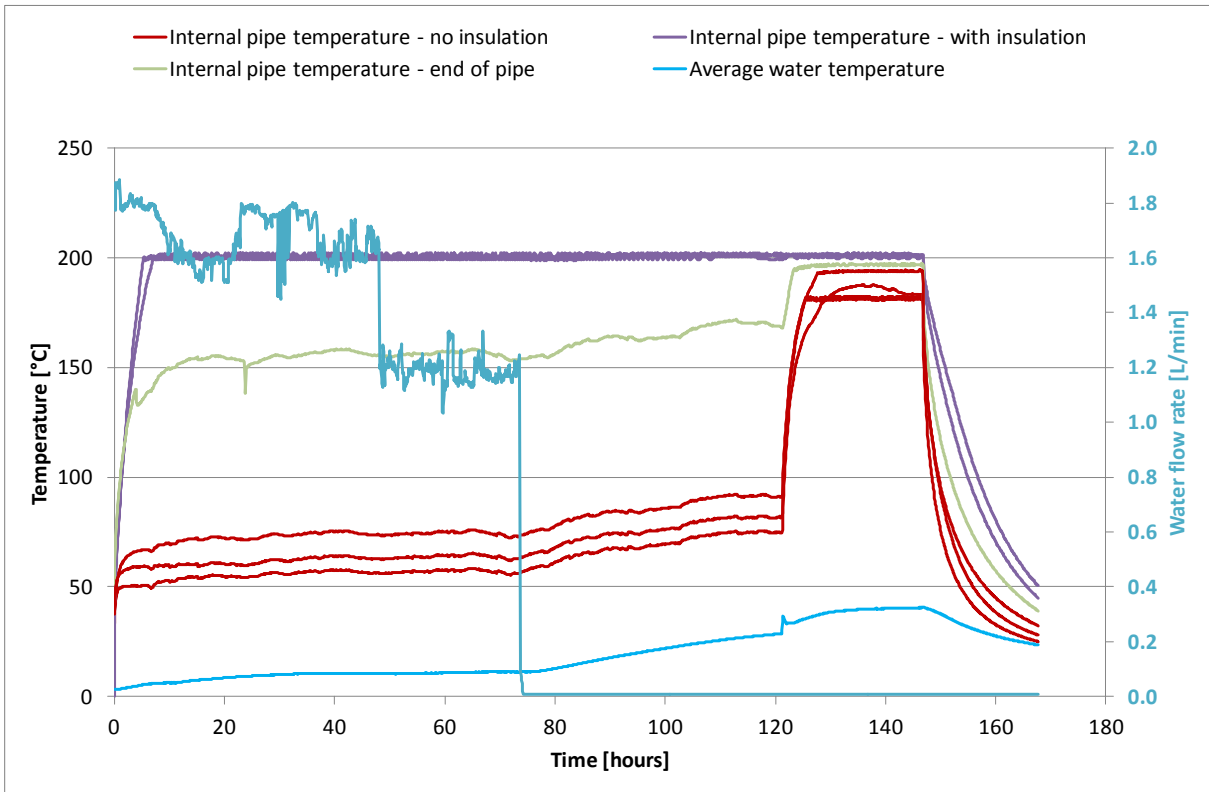
The first approach for the SST exposure involved housing the PTS in a specialist SST vessel equipped to provide an external water environment at 4°C and 40 bar pressure. However, it was observed that the internal heaters could not sufficiently heat the PTS in the regions where the insulation had been removed. The data log of internal pipe temperature, external water temperature and water flow rate are presented graphically in Figure 4.1. The heaters were started and within five hours the insulated sections of pipe had achieved the required test temperature of 200°C. By comparison, the anti-corrosion coated sections had only achieved an internal temperature of approximately 50 to 75°C. The set up was allowed to stabilize for 48 hours before reducing the water flow rate from 1.8 to 1.2 L/min. After a further 24 hours there was no discernible increase in the internal pipe temperature and the water flow rate was reduced to zero. The internal temperature of the pipe (anti-corrosion coated regions) is observed to rise but insufficiently so. The next step was to drain the water from the vessel at approx 120 hours. From this point on, the 'average water temperature' in reality is recording the air temperature in the vessel. From this point there is a sharp increase in the internal pipe temperature (anti-corrosion coated regions), however, the coated regions equilibrated at approximately 180 to 195°C. At this time the test was terminated.

Figure 4.1 SST Exposure #1 (hot/wet): Internal pipe temperature, water temperature and water flow rate

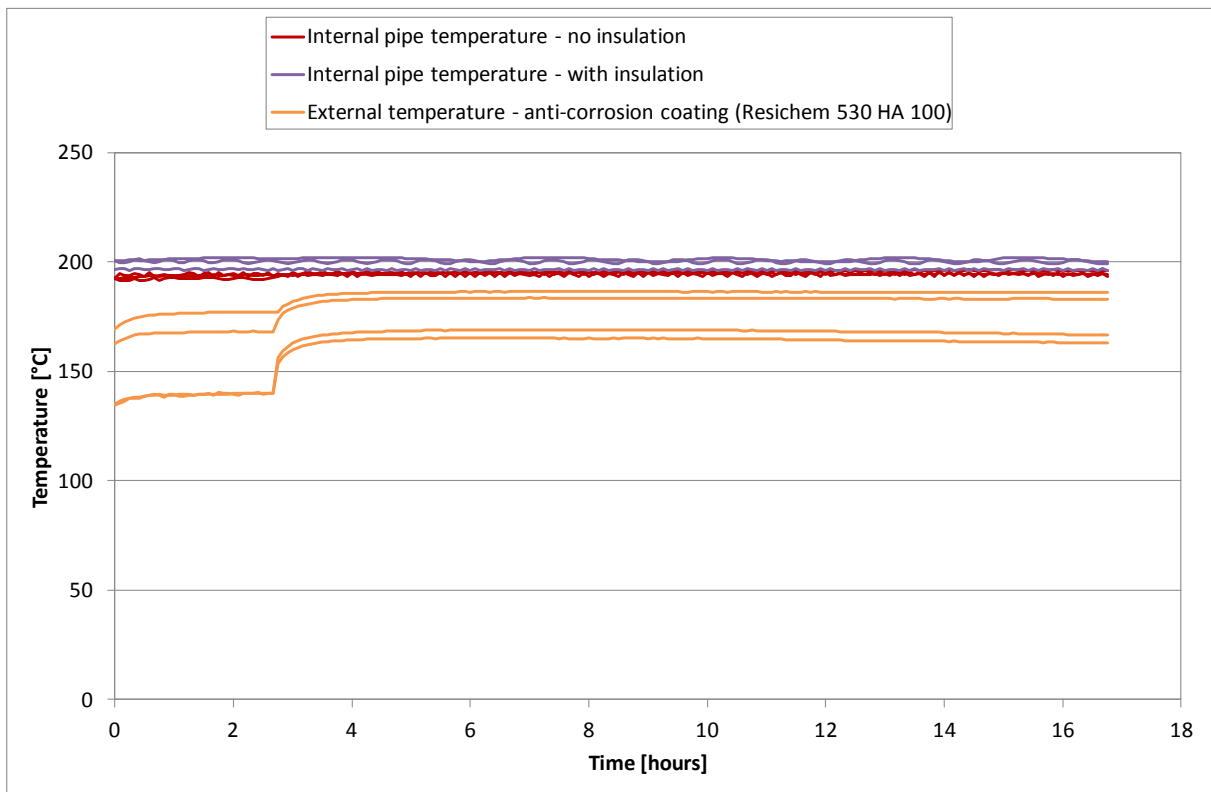
A second exposure using hot/dry conditions was defined. The PTS was removed from the SST vessel and the anti-corrosion sections loosely wrapped with fibreglass insulation. The internal pipe temperature of 200°C was achieved in both the insulated and anti-corrosion coated regions. The temperature was maintained for 16.7 hours as illustrated in Figure 4.2. The heating was terminated and the PTS allowed to cool to room temperature.

Figure 4.2 SST Exposure #2 (hot/dry): Internal and external pipe temperatures

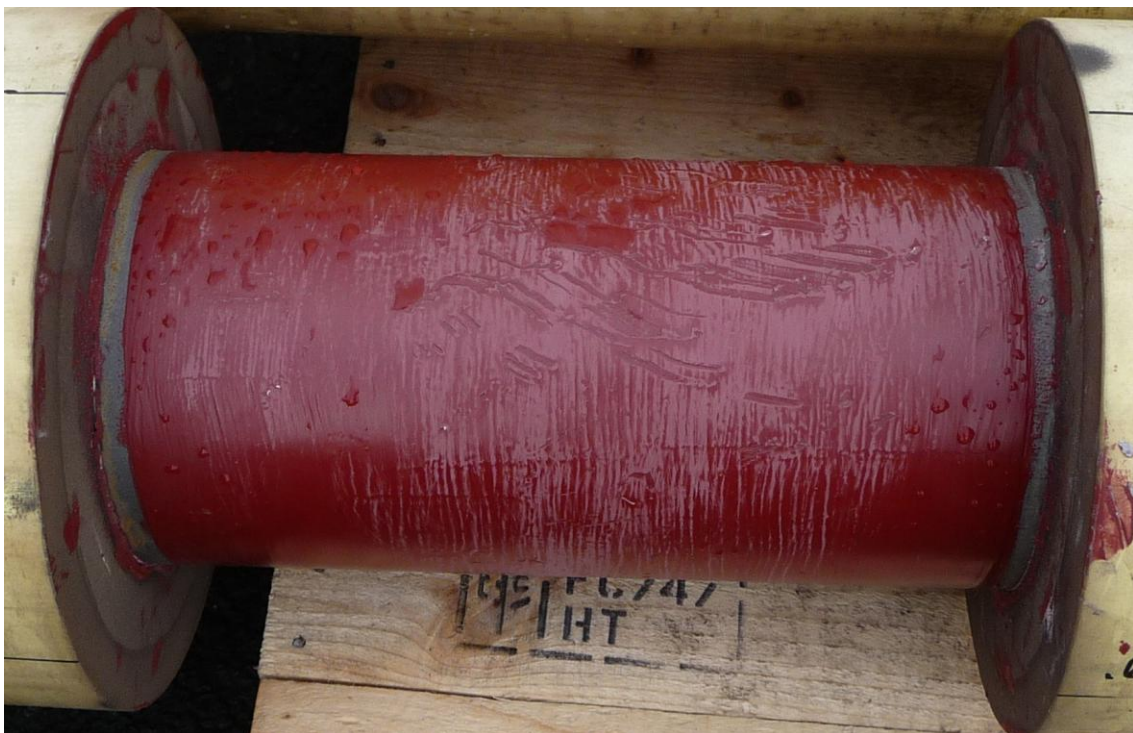
The before and after exposure photographs of the Resichem 530 HA 100 coated pipe sections are presented in Figure 5.1 and Figure 5.2 respectively. The main observations from the visual inspection are:

Figure 5.1 Resichem 530 HA 100 coating before exposure

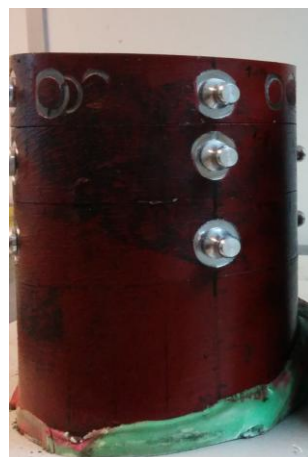
The coated pipe section with dollies attached is shown in Figure 5.3 with the test sample identification provided in Table 5.3. The individual results are included in Appendix B. The surface of the aluminum dollies were photographed after the pull-off test and are presented in Figure 5.4. The average maximum stress and error range for each coating is presented in Figure 5.5.

Figure 5.3: Section coated pipe with dollies attached

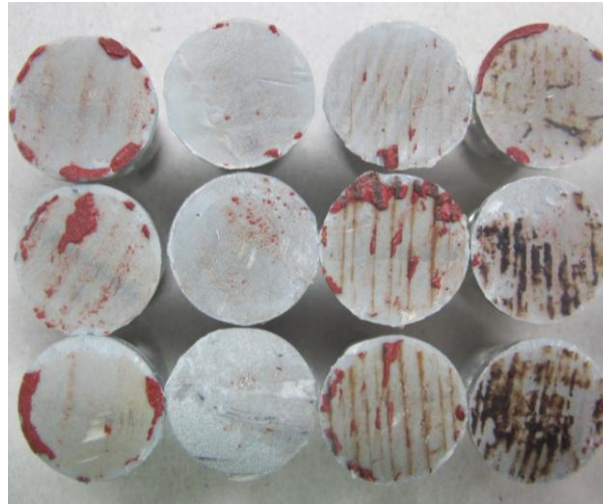
As illustrated in Figure 5.4 the Resichem 530 HA 100 coating exhibits failure mainly at the adhesive / coating interface with small amounts of coating visible on the surface of the dollies – most of the coating remains attached to the pipe. Therefore, in these cases the maximum stress is not a true measure of the bond strength of the coating to the pipe. That is, the anti-corrosion coating is bonded more strongly to the pipe than to the aluminum dollies.

Figure 5.4: Aluminium dollies after pull of test from Resichem 530 HA 100 coating
